# Watershed Restoration Technical Bulletin *Streamline*

Vol. 4 No. 3

## Watershed Restoration in Deer Creek, Washington – A Ten Year Review

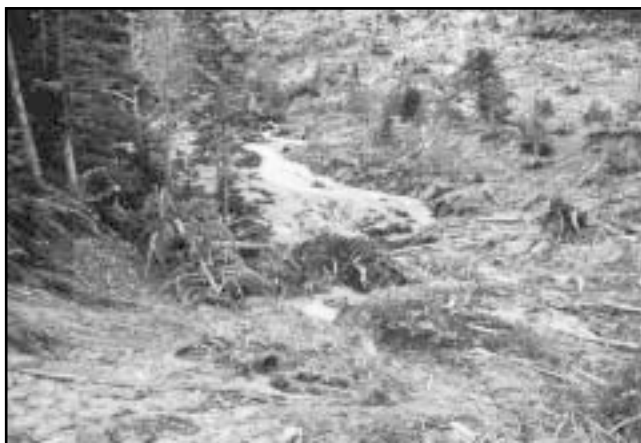
Figure 1. As shown in this pre-project photo, a Deer Creek tributary was chosen for large woody debris placement, sediment storage and bank stabilization.

The U.S. Forest Service began to conduct stream and fish habitat surveys in Deer Creek in 1979 and early in the 1980's. Beginning in 1984, the Mt. Baker Snoqualmie National Forest took the lead in conducting watershed-wide resource inventories and assessments. Figure 1 demonstrates upslope and stream conditions prior to the restoration projects. Based on the findings from these early inventories and assessments, the restoration strategy in the Deer Creek Watershed focused on modifying or altering the sedimentation process. The strategy was to reduce the coarse sediment delivery to the stream channel network and to mechanically stabilize the riparian sideslopes and streambanks. This was intended to lead eventually to riparian revegetation, stream channel recovery, and fish habitat improvement.

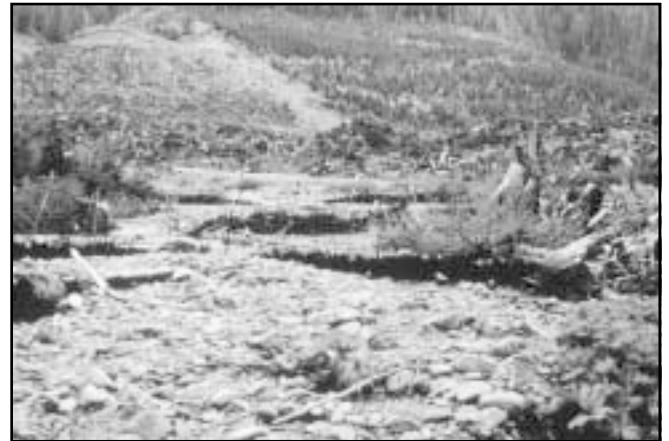
Figure 2. Looking upstream at this tributary, showing the initial upslope treatment which included sediment storage.

Figures 2 and 3 show the conditions following the restoration projects. This strategy employed two tactical operations: 1) restoration efforts that involved road, upland, and in-channel projects; and 2) restoration efforts that would be carried out over a multi-year period and would cover the entire watershed.

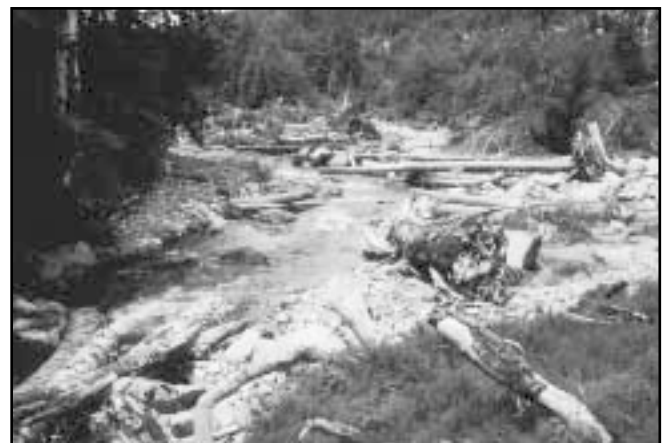
Figure 3. Deer Creek four years after the photo in figure 1. This stream has benefitted from LWD placement and bank stabilization.
