# Hillslope Restoration - Biotechnical Soil Stabilization Demonstration Sites

*Pierre Rossouw and Ernie Carson*

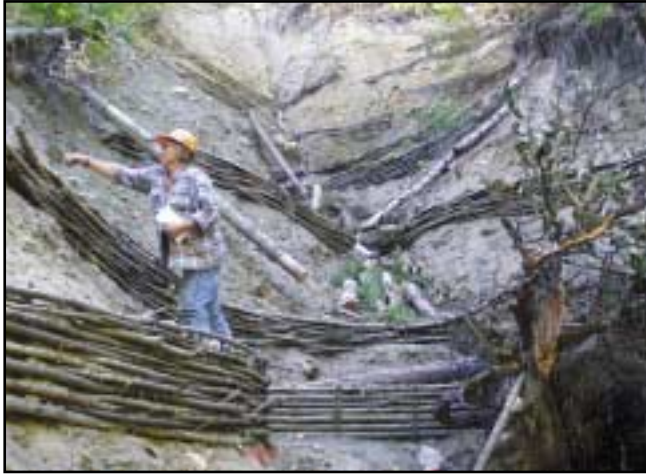
Figure 2. Gully treatment at Cooke Creek FSR 1.7 km. The wattle fences were configured in the form of “arrow heads” to dissipate energy and arrest downcutting.

The third demonstration site was a deeply incised gully formed by ditch water flow off a switchback on the Cooke Creek FSR at 1.7 km. The ditchline above the switchback carries water for some 400 meters to flow out onto unstable, 60% slopes. The result has been the formation of a deep gully in the unstable till material of the slope. The sidewalls of the gully have become unstable, and on the adjacent hillslope are extensive tension cracks, associated with a loss of toe support at the gully. The most obvious solution in a case such as this is the introduction of cross culverts above the switchback to lessen flow and lead ditch water onto the flatter terrain below this part of the road. Unfortunately, cross culverts on this section of road would discharge ditch water directly above private property. As this could cause damage to the private property, forest road managers have not been able to install culverts in this section of road.

The tension cracks and other obvious signs of instability and eminent failure in the gully led to the decision to proceed with treatment of the gully before additional culverts could be introduced, and without lessening of the flow. This deeply incised gully is approximately 6 meters deep with steep sidewalls. Restoration objectives in this instance were to arrest down-cutting and loss of toe support, and to treat the sidewalls. To achieve these objectives, wattle fences were constructed on the sidewalls. These have a 2% fall to the center of the gully, and were configured in the form of "arrow heads." In this treatment, the wattle fences meet in the center of the gully forming appropriate gully breaks to dissipate energy and to arrest down-cutting (Figure 2). Work at this site was undertaken in the fall of 1998. Because the site is fairly wet, there has been vigorous growth and the treatment is successful at this stage.

Acting as lead proponent for restoration work in the Brash Creek Watershed, Spallumcheen Band has subsequently had success using the "arrow head" configuration of wattle fences in a similar circumstance. Brash Creek is a community watershed a few tributaries to the South of Cooke Creek.

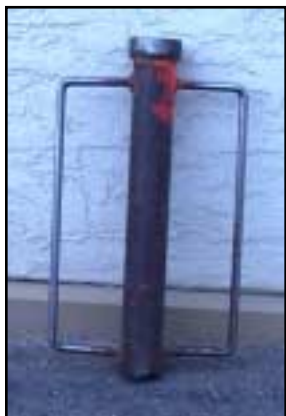
Figure 3. Specialized rebar pounding tool made out of pipe and bars.

4. 20M rebar is far more effective than 15M.
5. A specialized rebar pounding tool can be made out of pipe and bars (Figure 3). With proper design, the pounding of rebar for wattle fences and modified brush layers can be made significantly easier. (Editor's Note: WRP courses are now suggesting the use of wooden stakes (sapling stakes) instead of rebar because rebar is not biodegradable

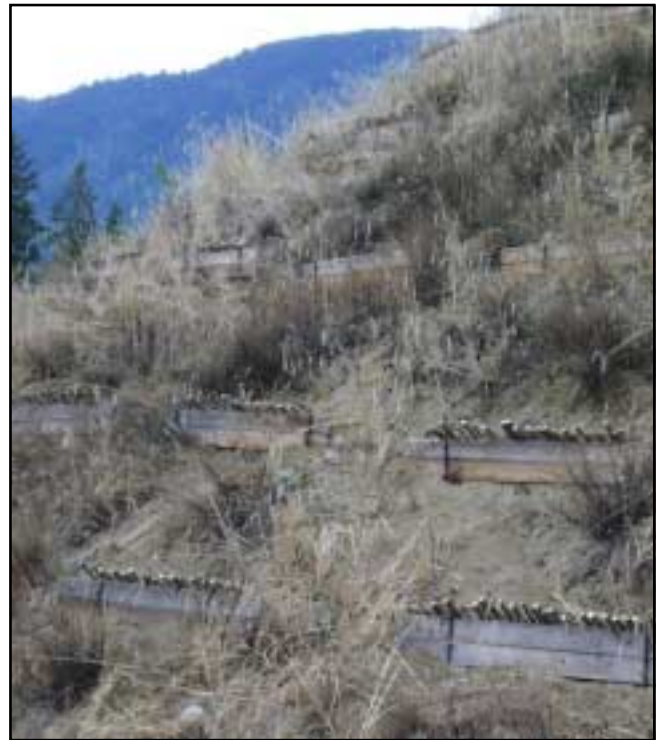
Figure 4. At this site, cedar planks were successfully utilized in modified brush layers.

6. Use cedar planks (5/8" x 8") for modified brush layers (Figure 4). Individual cedar planks are: (i) easily transported in bundles on site; (ii) light and rot-resistant; and (iii) easily cut with a hand saw, eliminating the need for chain saws and all the regulations associated with their use.

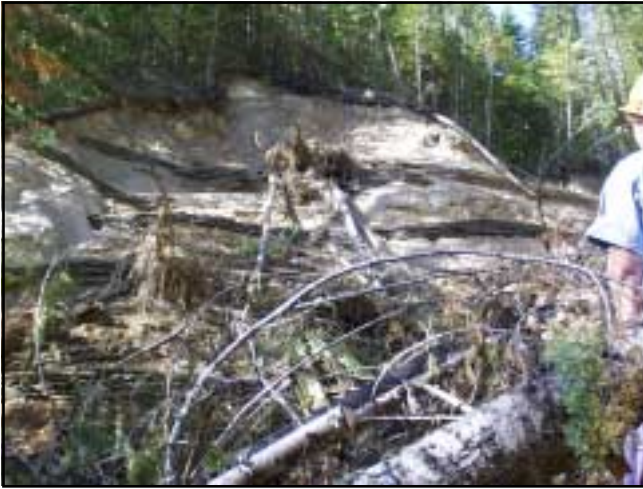
Figure 5. Non-danger trees remain on the margins of the slide providing a seed source. If they do fall into the slide area they can provide a stabilizing effect and bring additional organic matter onto the slope.

7. Live pole drains work best when the tops of the bundles are partially exposed.
8. Wattle fences at the toe of the escarpment will catch some of the raveling wall, but may fail or be covered if too much raveling takes place.
9. Leave non-danger trees on the margins of the slide. Such trees are a potential seed source for the successional growth of conifers on the slide. In addition, if they do fall into the slide area they provide a natural stabilizing effect and can bring organic matter down onto the rehabilitating slope (Figure 5).
10. With proper, controlled application of fertilizers, accelerated grass/legume growth can occur. This also assists in the establishment and growth of cuttings.
