Watershed Restoration Technical Bulletin

Vol. 5 No. 1

Nitinat River WRP: Tsuk-si-tay Groundwater Side Channel and Upslope Management

Deborah Epps

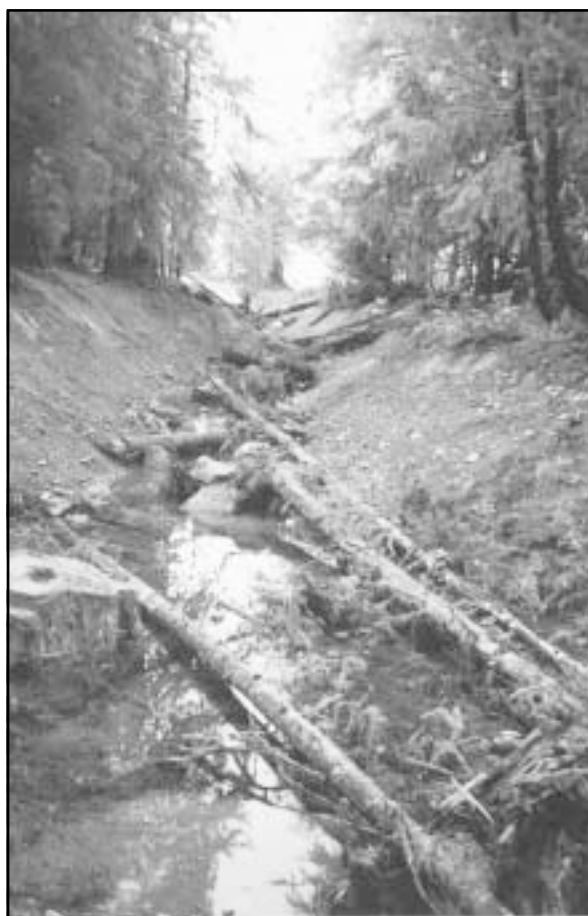
Figure 2. Typical channel view, upper end, showing rock and wood complexing.

Construction of the channel commenced July 12, 1999 and was completed by September 13, 1999. Two excavators (CAT330 and CAT320), two off-road rock trucks for end hauling, and a D-6 Cat bulldozer were used during the project. The machines worked in tandem to move the large volumes of materials. The brush was removed first, followed by the removal of topsoil (to dump sites), removal of the first pass of gravel to ground water table, removal of the second pass of gravel to grade (all gravel used on berm), and finally, complexing with rock and wood (Figure 2).

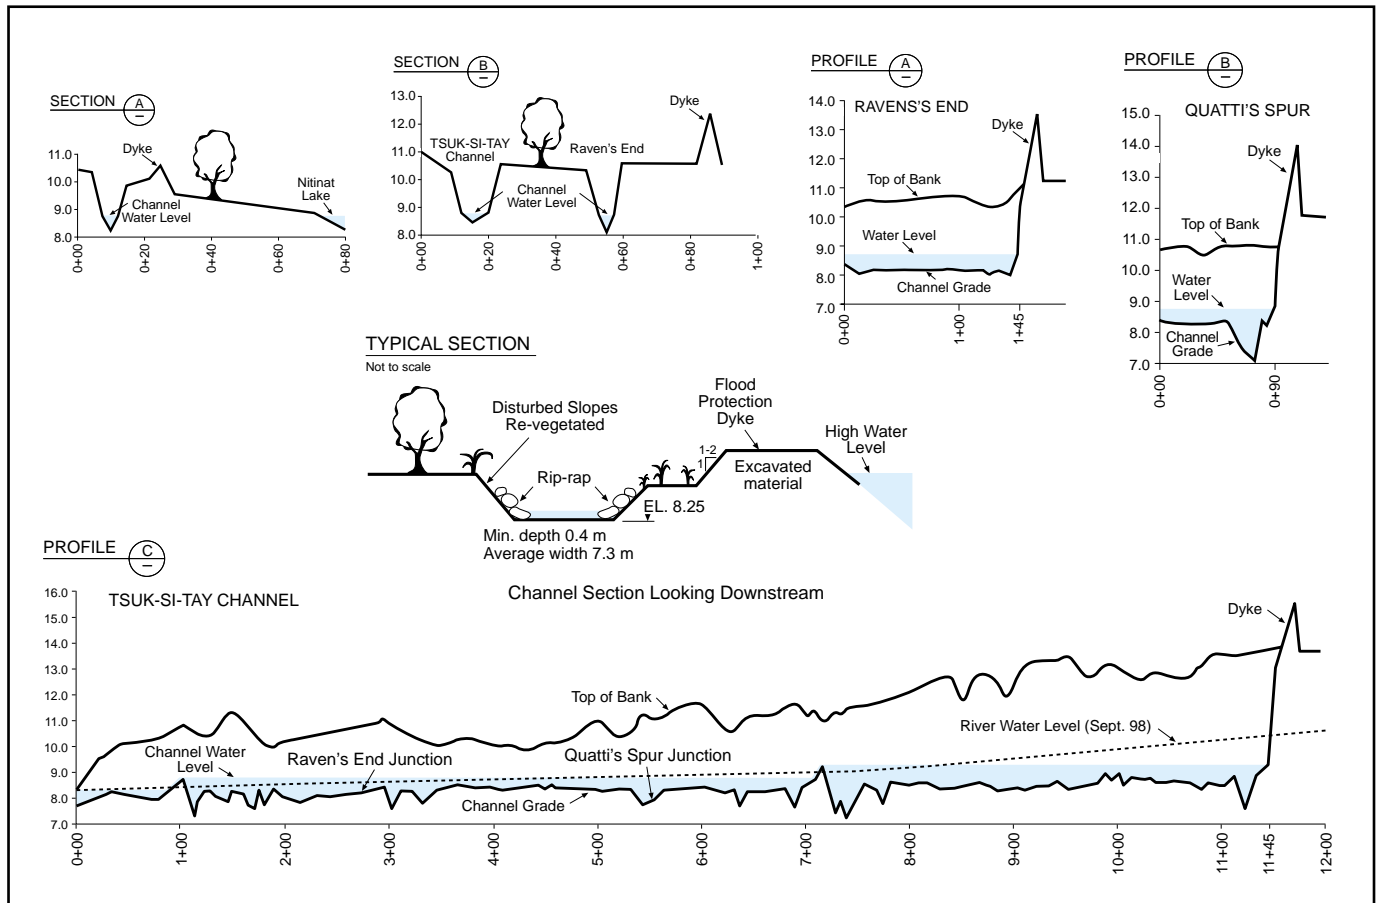
Figure 4. Examples of some of the Caycuse River Tsuk-si-tay Groundwater Channel Sections and Profiles - As Built.

weeks. The mainstem of the channel is 1,145 m in length, the upper spur is 90 m, and the lower spur is 145 m, for a total length of 1,380 m (Figure 3). Average channel width is approximately 7 m, giving the channel a surface area of 10,065 m². Depths in the channel range from 0.3 m to 1.2 m in the pools (Figure 4).

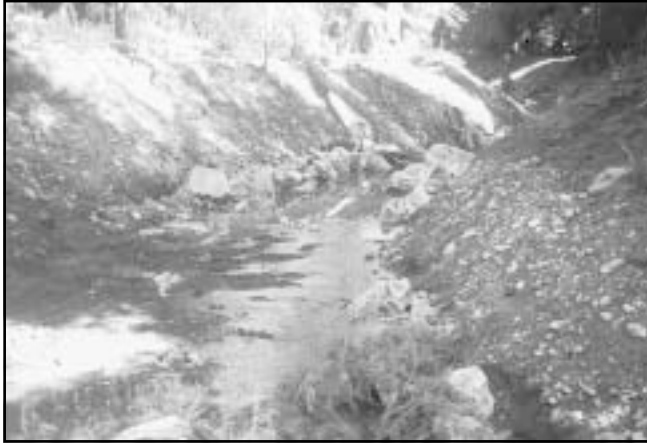
Figure 5. Rock is placed along the toe of the channel to prevent spawning chum from digging into the banks.

Adding complexity took between three and four weeks to complete. There have been approximately 500 LWD stumps and 1200 m³ of rock added to the channel. The rock was placed along the toe of the channel to help avoid bank cutting from spawning chum and to provide rearing habitat for coho fry (Figure 5).

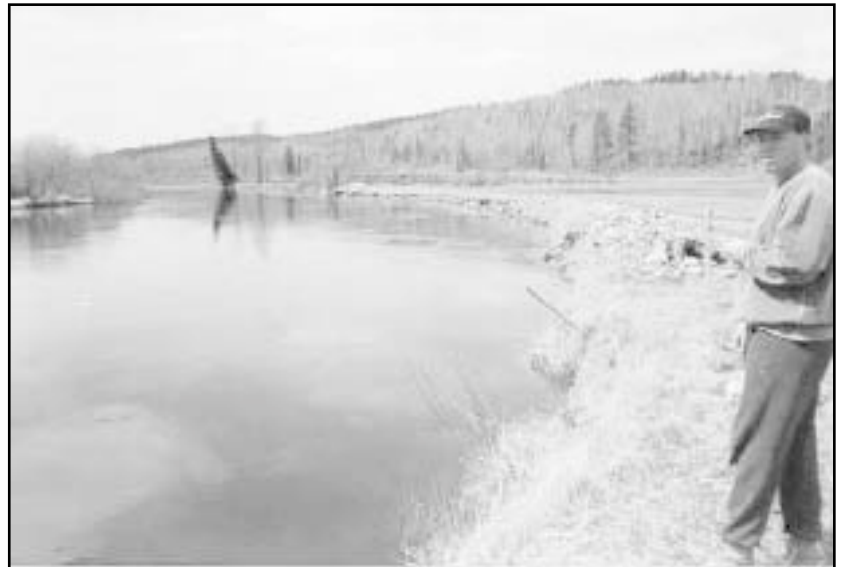
Figure 1. A section of the Horsefly River where debris groins are a bank stabilization option.

Debris groins are currently being considered for a reach of the Horsefly River which lacks riparian vegetation as it flows adjacent to an open field (Figure 1). The heavy machinery required to construct the groins will access the site from the open field. Since the proposed groins can be installed with the required machinery operating adjacent to the river, it is anticipated that construction activity necessary for debris groins will not affect the water quality in the mainstem during construction.
