# Ramsey Creek: 2000–2001 Riparian Restoration and Enhancement

Chris Rossel, Gary Asbridge, Rich Thurman, and John Dodd

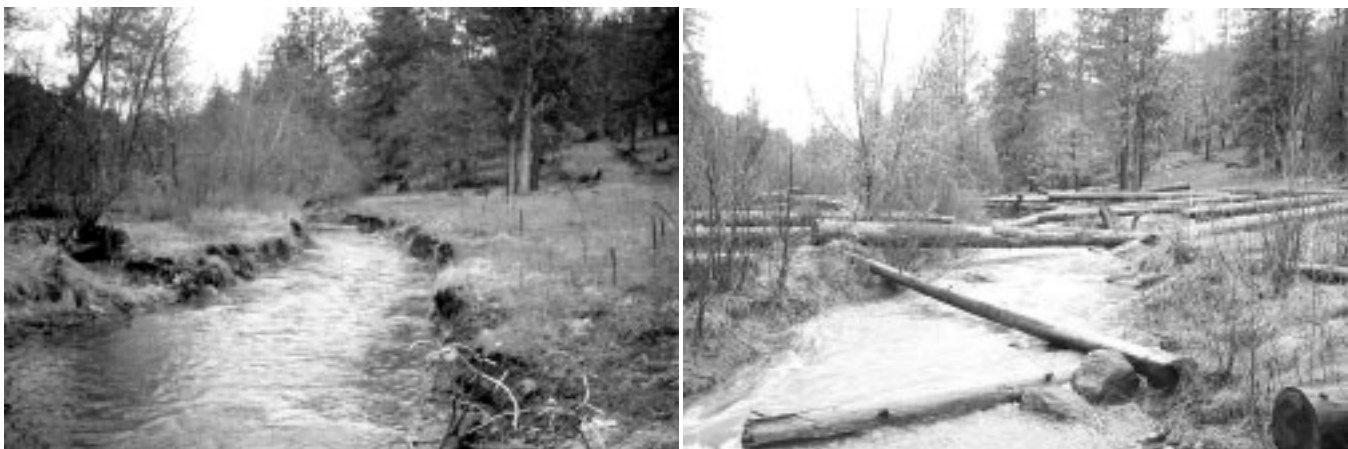
habitat, by causing channel down cutting, loss of connectivity of the stream channel to the floodplain, increased fine sediment, and loss of stream channel vegetation (Figure 2). The previous timber harvesting and

Figure 2. Ramsey Creek Forest Boundary before (1998) and after (2002) restoration work, Mt. Hood National Forest.

We placed about 1400 logs in and beside the stream channel in a 5-km project reach. Logs placed in the channel were to provide direct cover for fish, create and maintain pool habitat, and ultimately reconnect the stream channel to the floodplain through aggradation of the stream channel. As the channel aggrades over time, stream gradient should decrease and stream length increase, thus increasing the ability of bankfull or greater flows to overflow into the floodplain. More frequent overbank flows disperse water over a larger area and reduce water velocities, thereby reducing the potential for downcutting and bank erosion to occur (Figure 3). Inundation of water into the floodplain should recharge the riparian area with water and sediment, while improving vegetation growth.

Most wood (60–70%) was placed in the floodplain because we anticipated the stream will shift course due to in-channel wood placement. The wood placed in the floodplain will help regulate the rate of stream channel shifting, reduce erosion when it does shift, and become new in-channel habitat when the stream shifts course. Large wood on the floodplain also reduces the amount of

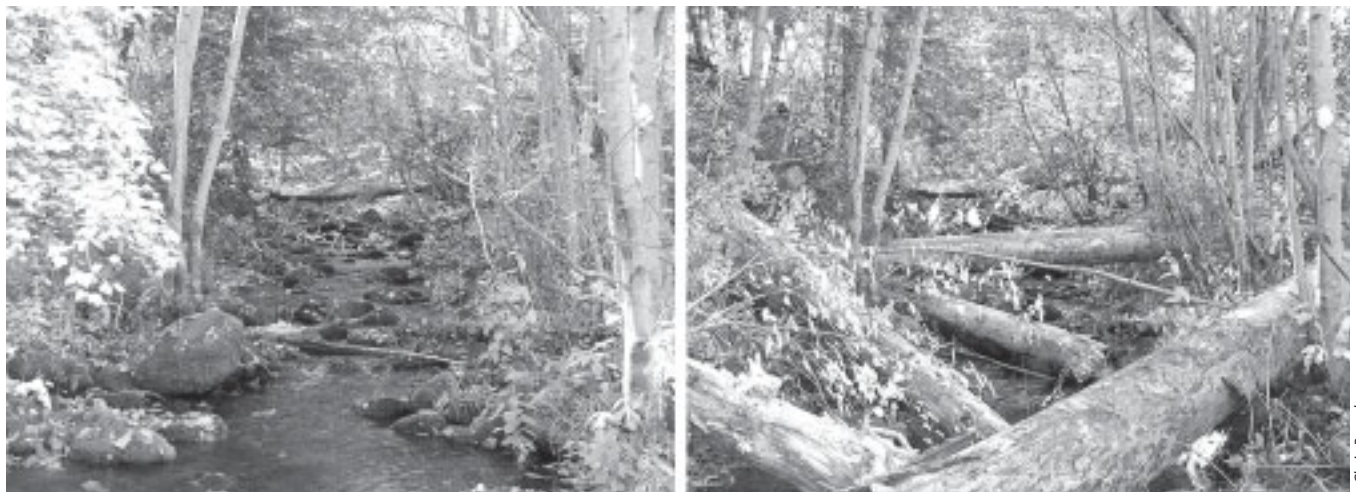
Figure 3. Ramsey Creek before log and after log placement.

Some of the excavated pools will shallow up after a few freshets, but meanwhile they will provide quality spawning and rearing fish habitat. In the long term, the high level of large wood that has been placed in the stream channel will create and maintain pool habitat.
