Integrated Watershed Restoration Projects

Upper Willow Watershed Effectiveness Evaluation Strategy

Project Description

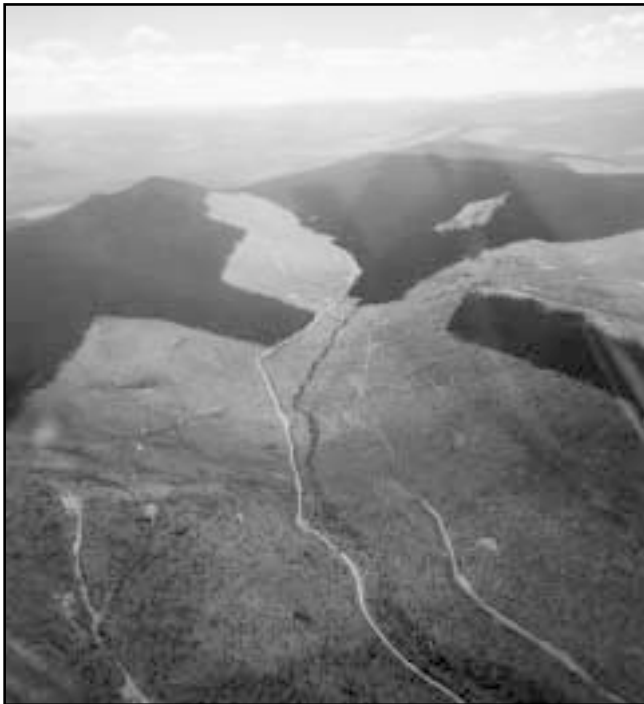
Figure 1. This photograph shows the Rebman Creek watershed, one of the areas with peak flow concerns.

An Integrated Watershed Restoration Plan (IWRP) was completed and a high value of fish habitat in the watershed was established. Restoration was necessary because of the many potential sediment sources caused by a high density of roads, and a peak flow risk resulting from a large clear-cut area (Figure 1).

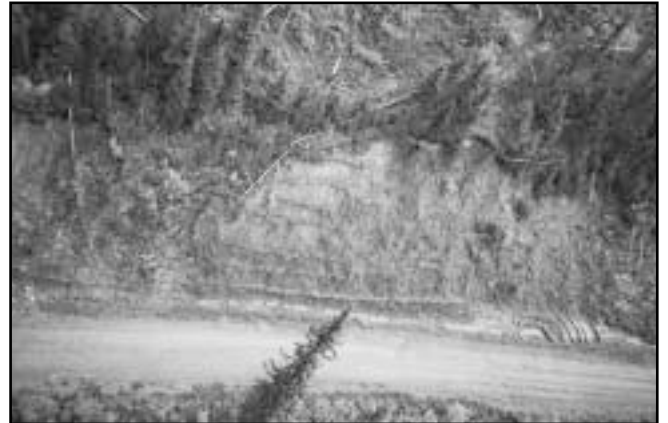
Figure 2. Hillslope stabilization along this roadway involved wattle fencing, brush layers, live silt fences, willow staking, and hydroseeding. Willow and cottonwood were the species used.

Hillslope Stabilization: The soil bioengineering was very successful so far (Figure 2). At the Demonstration Site there have been no new slope failures in the treated area, while there was one in the untreated control, and the percent of structures in place and

growing is near 100% (1 year of data). Areas with pullback have not had any new failures (immediately post-work data only).

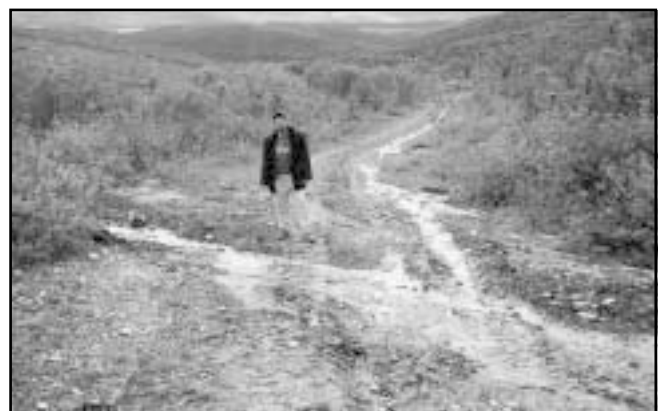
Figure 3. Post-work photo of 4WD Template cross-ditch breached since repairs.

Surface Erosion Control: The length of road with water running down it had mixed results; some areas will be reconstructed in 2000. Erosion was present in many cross-ditches; armoring will be increased in 2000. Percent vegetative cover results are awaiting analysis. In fine soils, cross-ditches constructed to ATV templates all survived the fall rains; many of the 4WD cross-ditches had already failed after the fall rains (Figure 3). The length of road with surface erosion (including ditch) has been reduced, but some results are still forthcoming (immediately post-work data only).

- evidence of water flow, suggesting that placement of drains is sensitive (1 year data).
- Cross-ditches should be closely spaced to return the cutslope seepage water to groundwater: spacing depends on site characteristics, and is particular to the conditions encountered in the Willow Watershed.
 - Cross-ditches constructed in fine soils to ATV template had no breaches after the fall rains and hunting traffic; several constructed to 4WD template had been breached in the same conditions.
