Instream and Channel Restoration Projects

Durability of Pacific Northwest Instream Structures Following Floods

Project Description

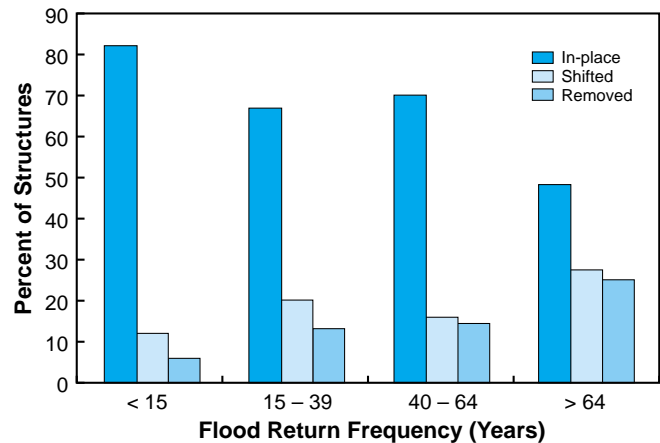
Figure 1. The relationship between flood magnitude and structure durability.

- Magnitude of flood events had a significant effect on structure durability with higher magnitude floods reducing durability (see Figure 1).
- Stream order also affected structure durability; structures in large streams were 20 times more likely to have been removed from the site of original placement than structures in small streams (see Figure 2).
